The Road Inventory of Tallahatchie National Wildlife Refuge

Grenada, MS

Prepared By: Federal Highway Administration Central Federal Lands Highway Division November, 2011

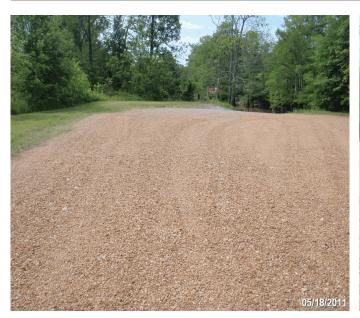
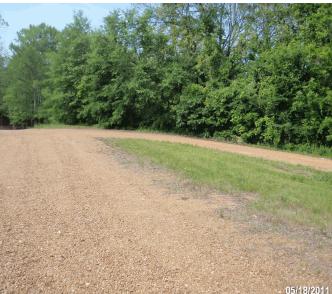
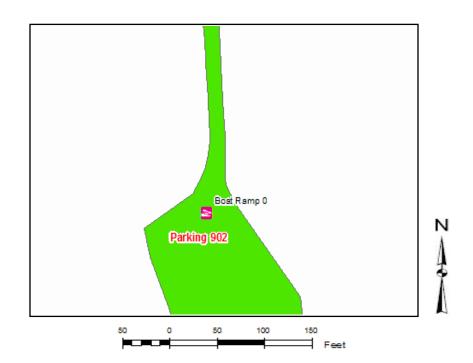
902: State Route 8 Boat Ramp Parking

. .				•
Asset Number	Date Visited	Surface Type	Area (Sq Ft)	Condition	Cost to Improve
10044526	05/18/2011	Gravel	27,842	Good	3,700

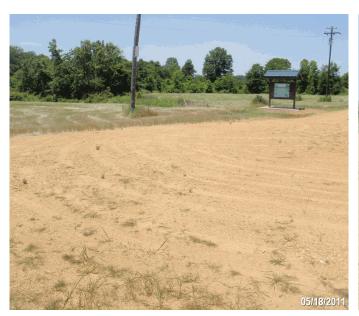
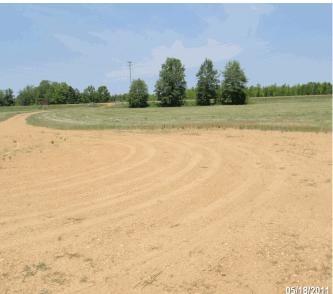
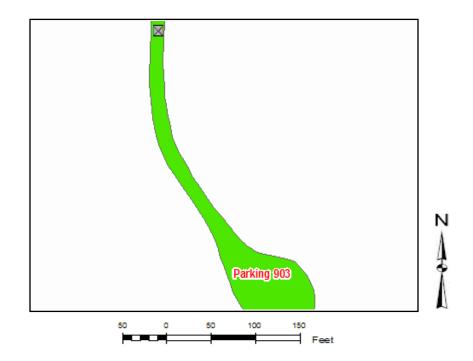
903: Grain Bin Parking

A 4	Dete	Conford	A		044-
Asset Number	Date Visited	Surface Type	Area (Sq Ft)	Condition	Cost to Improve
10049185	05/18/2011	Gravel	15,843	Good	2,100

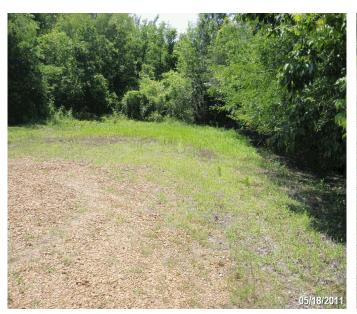
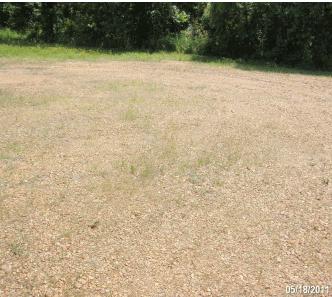
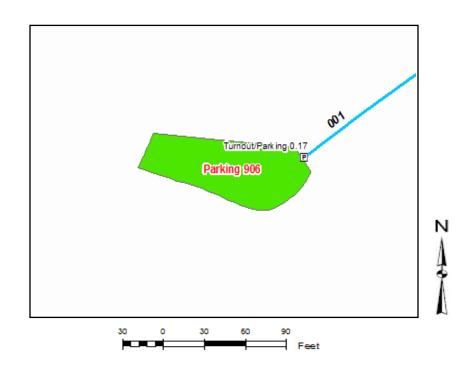
906: Horse Barn Loop Cutoff Parking

_		
Asset	Date	Surface	Area	Condition	Cost to
Number	Visited	Type	(Sq Ft)	Condition	Improve
	05/18/2011	Gravel	5,439	Good	700

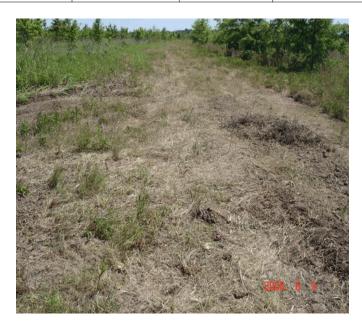
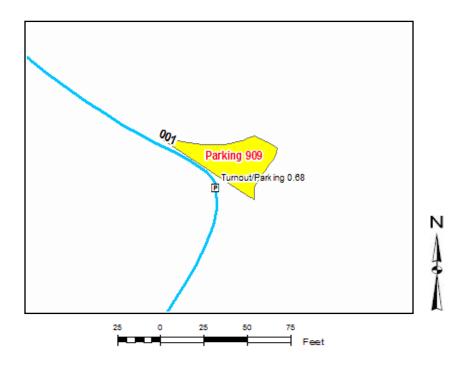
909: South Entrance Parking #1

Asset Number	Date Visited	Surface Type	Area (Sq Ft)	Condition	Cost to Improve
ł		06/09/2006	Native	1,267	Fair	300

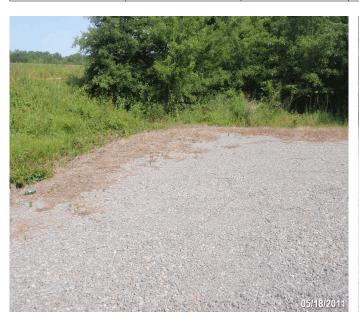
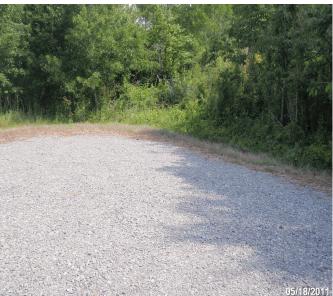
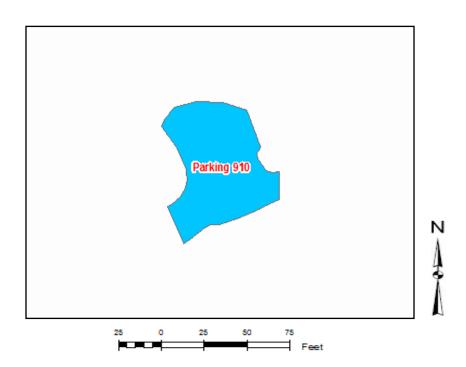
910: Boardwalk Parking

Asset Number	Date Visited	Surface Type	Area (Sq Ft)	Condition	Cost to Improve
10061268	05/18/2011	Gravel	4,285	Excellent	0

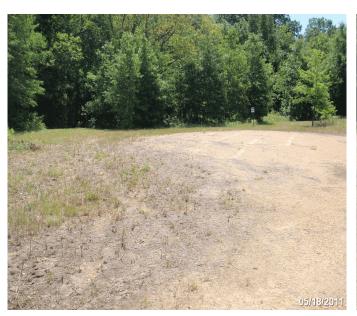
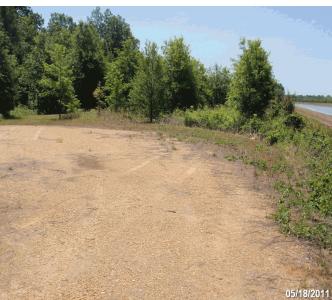
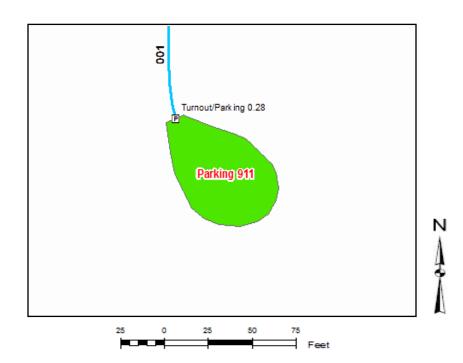
911: Sayle Parking #2

Ī						
	Asset	Date	Surface	Area	Condition	Cost to
	Number	Visited	Туре	(Sq Ft)	Condition	Improve
Ī		05/18/2011	Gravel	3,302	Good	400

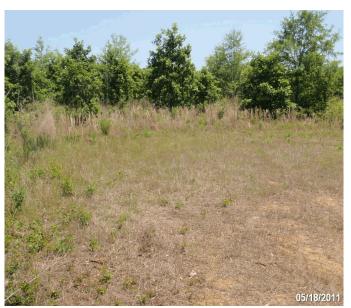
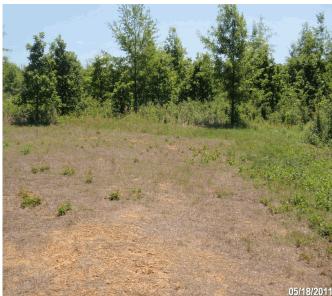
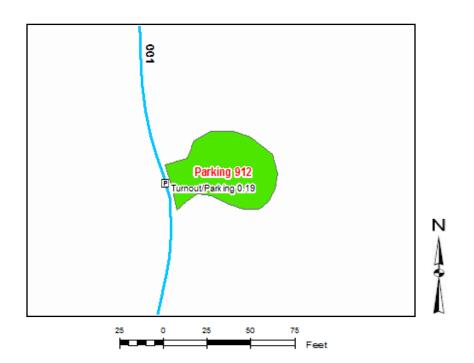
912: Sayle Parking #1

Asset	Date	Surface	Area	Condition	Cost to
Number	Visited	Type	(Sg Ft)		Improve
	5/18/2011	Gravel	2,480	Good	300

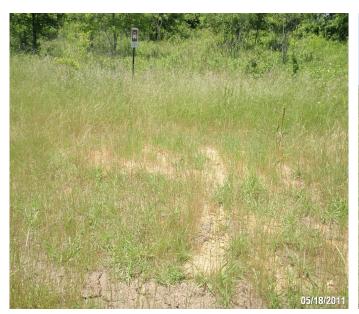
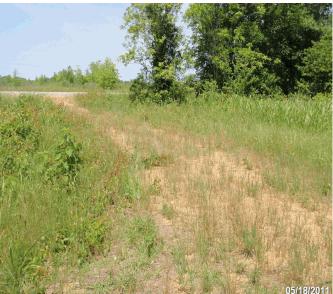
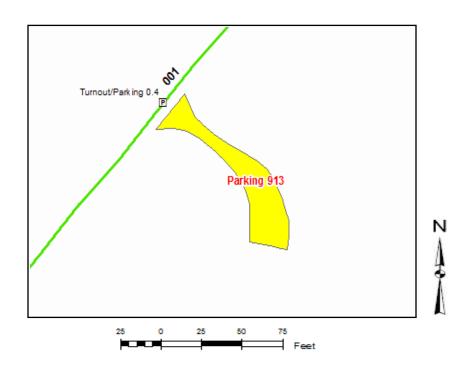
913: Tippo Trail North Parking

Asset	Date	Surface	Area	Condition	Cost to
Number	Visited	Type	(Sq Ft)		Improve
	05/18/2011	Gravel	2.128	Fair	500

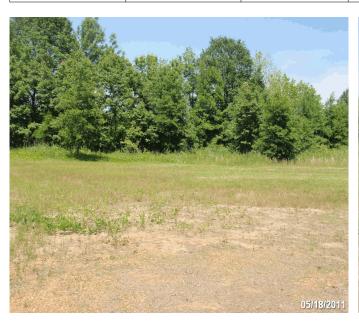
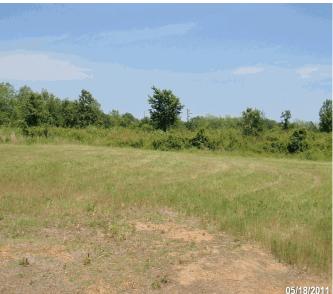
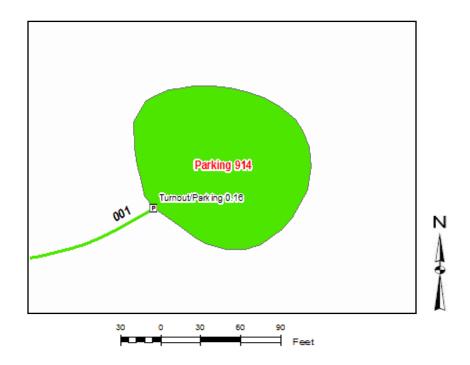
914: Cypress Parking

Asset	Date	Surface	Area	Condition	Cost to
Number	Visited	Type	(Sq Ft)		Improve
	05/18/2011	Native	15.215	Good	2,000

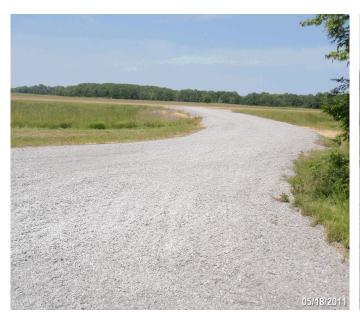
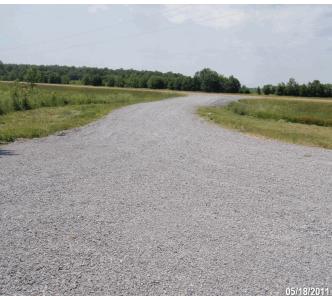
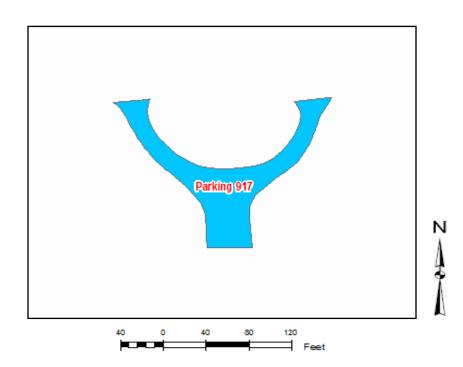
917: Fishing Pier parking

Asset Number	Date Visited	Surface Type	Area (Sq Ft)	Condition	Cost to
	7.0.10	.,,,,,	(04:0)		p.cvc
10061850	05/18/2011	Gravel	8,721	Excellent	0

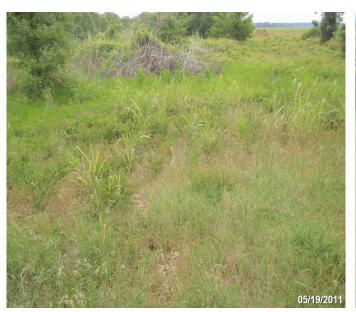
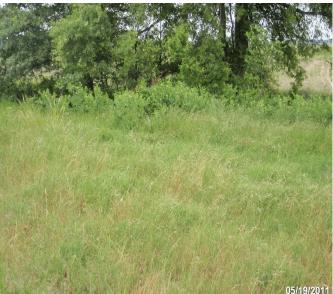
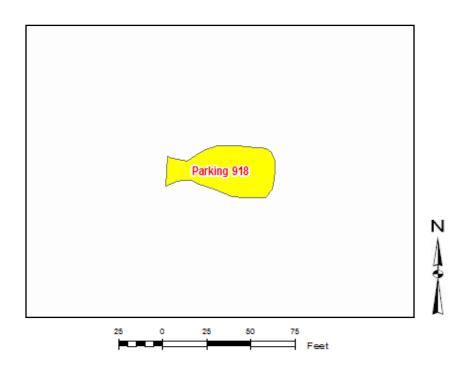
918: Gwin Tract Parking

Asset Number	Date Visited	Surface Type	Area (Sq Ft)	Condition	Cost to
Number	Violeda	1,700	(04:1)		IIIIpiove
	05/18/2011	Native	1,633	Fair	400

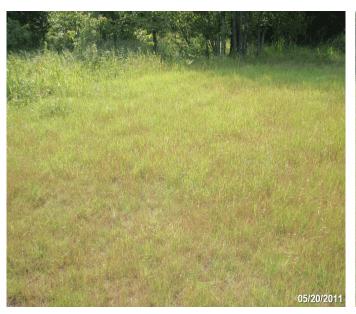
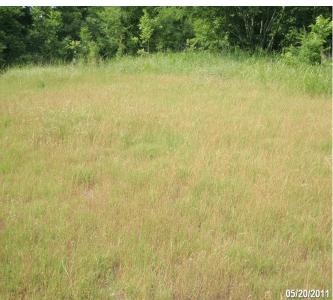
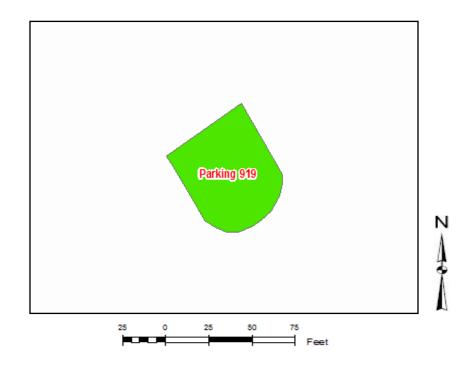
919: Robertson Tract Parking

_		
Asset	Date	Surface	Area	Condition	Cost to
Number	Visited	Туре	(Sq Ft)	Condition	Improve
	05/20/2011	Native	3,644	Good	500

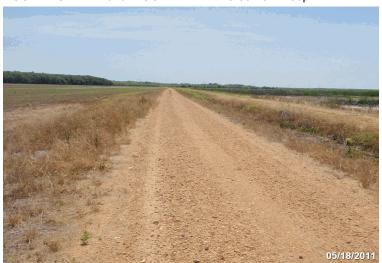
Photo # TALL_C4_0066 - MP 0.00 - Begin Section 001 ROUTE NUMBER: 010 ROUTE NAME: Horse Barn Loop
